PERATION

GREENHOUSE

SCIENTIFIC DIRECTOR'S REPORT

ANNEX 3.2 U. S. NAVY STRUCTURES

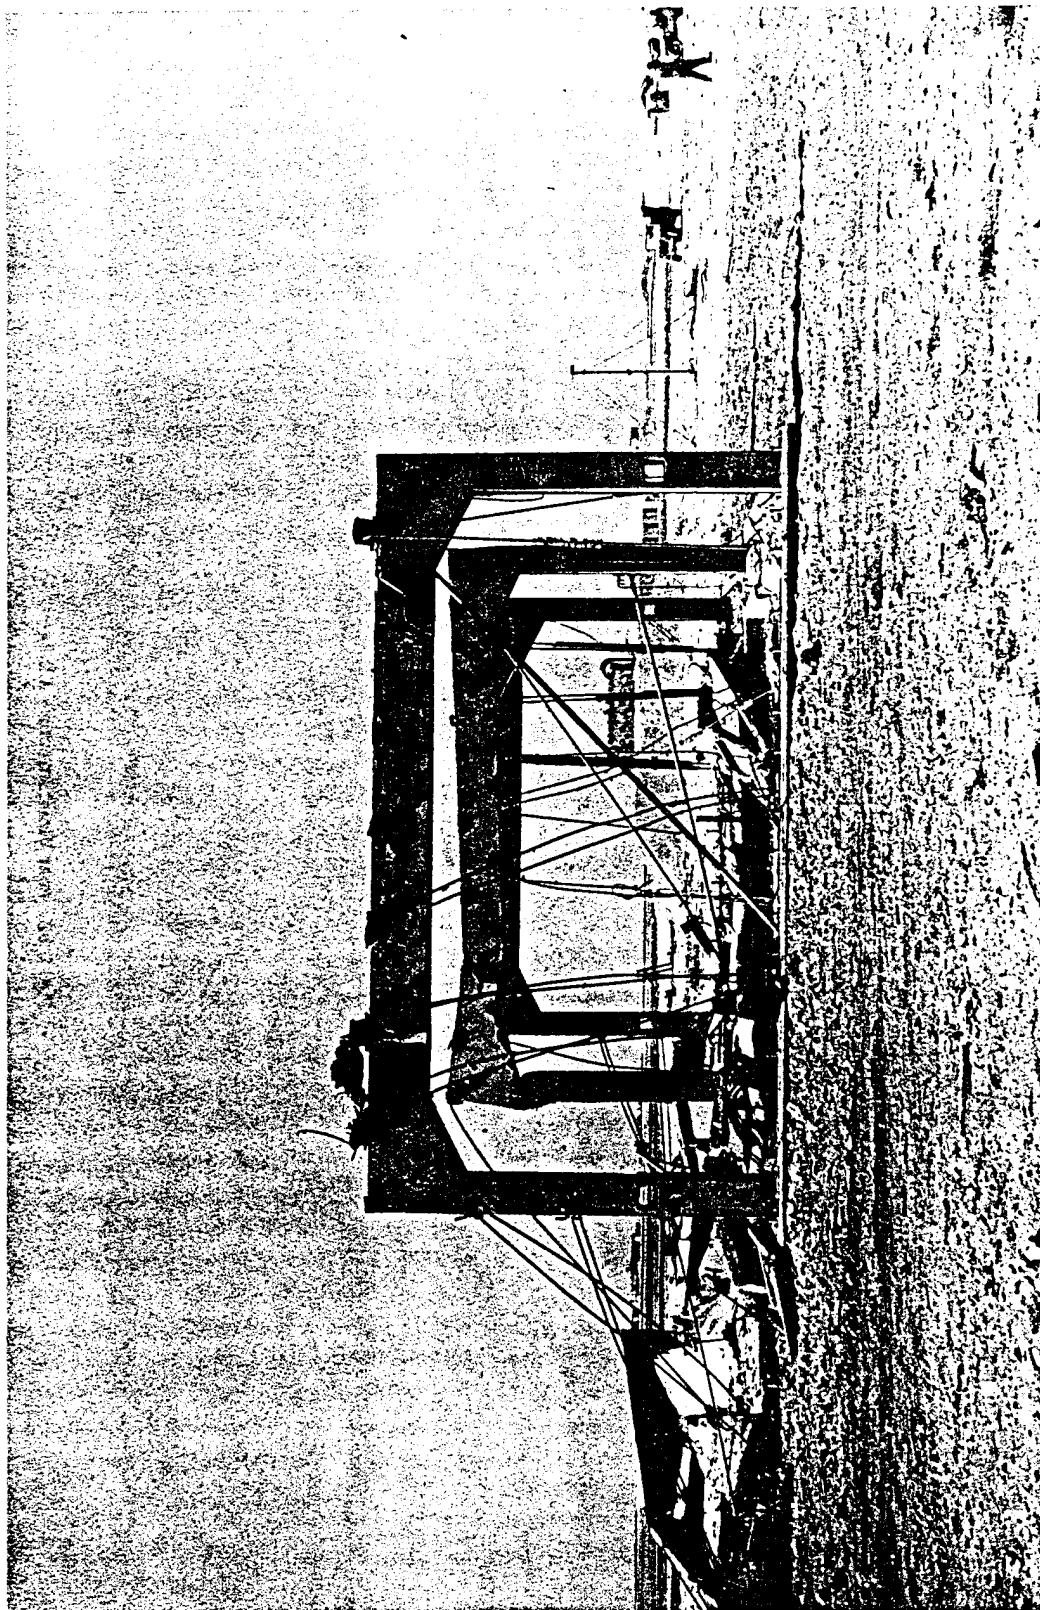
Fig. L.51 Left Side, Structure 3.2.2a

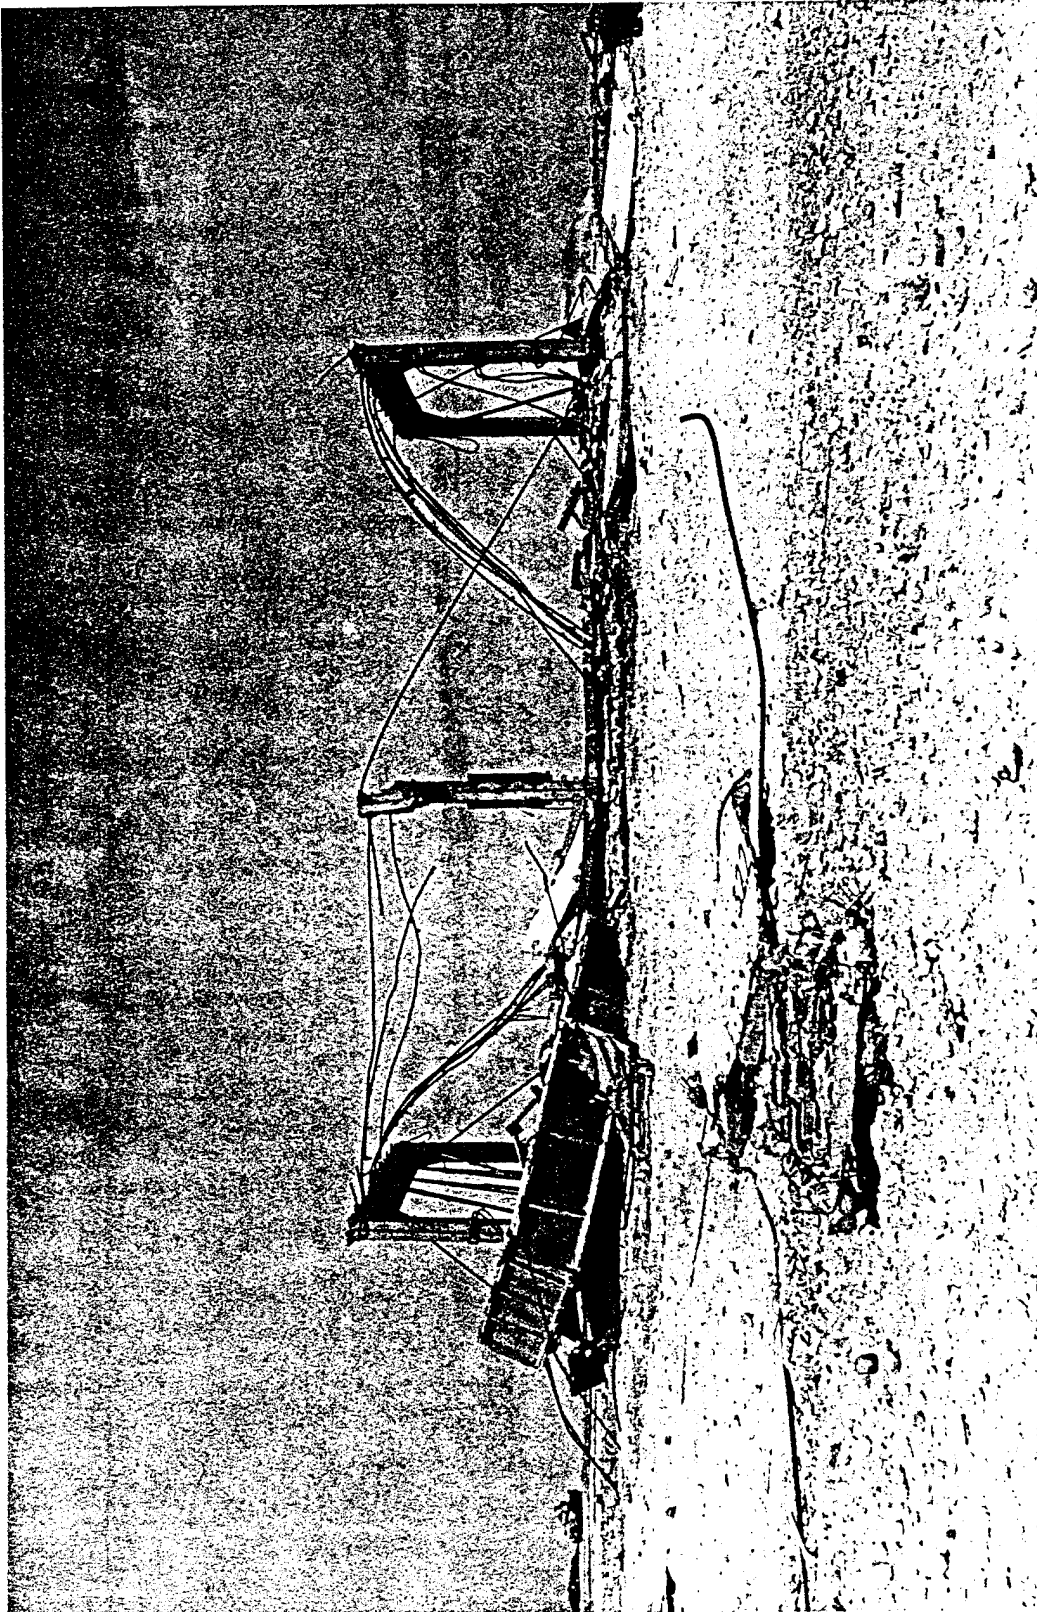
Fig. L.52 Rear View, Structure 3.2.2a

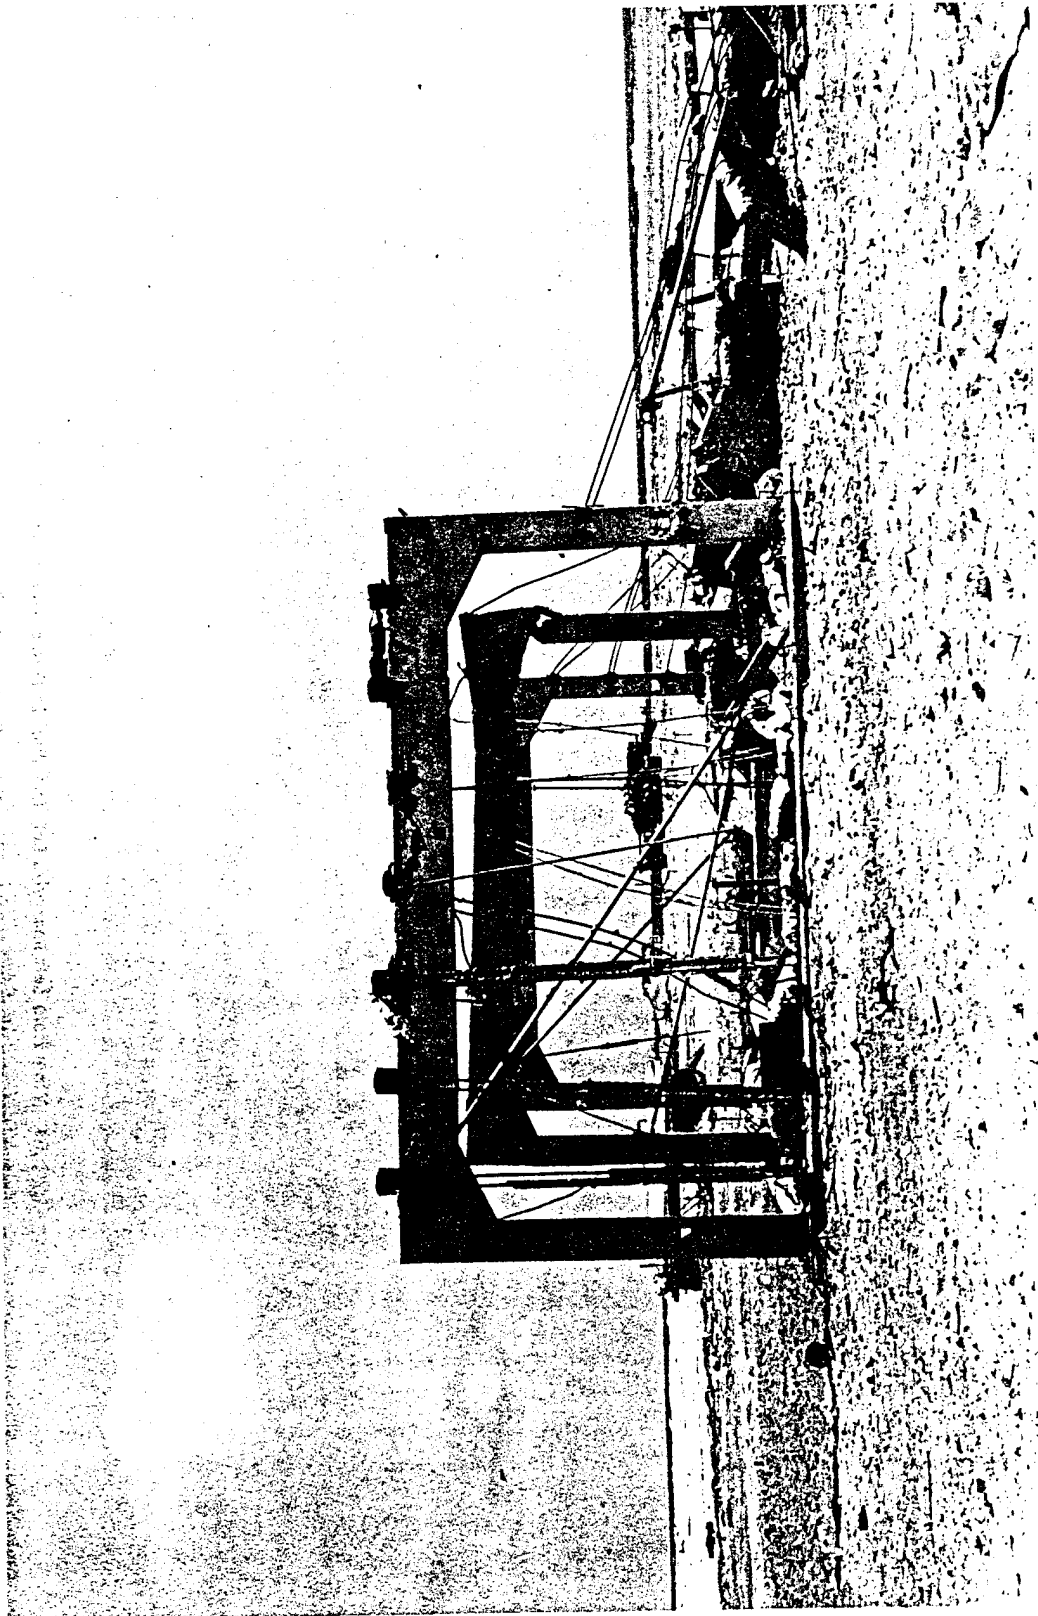
Fig. L.53 Right Side, Structure 3.2.2a

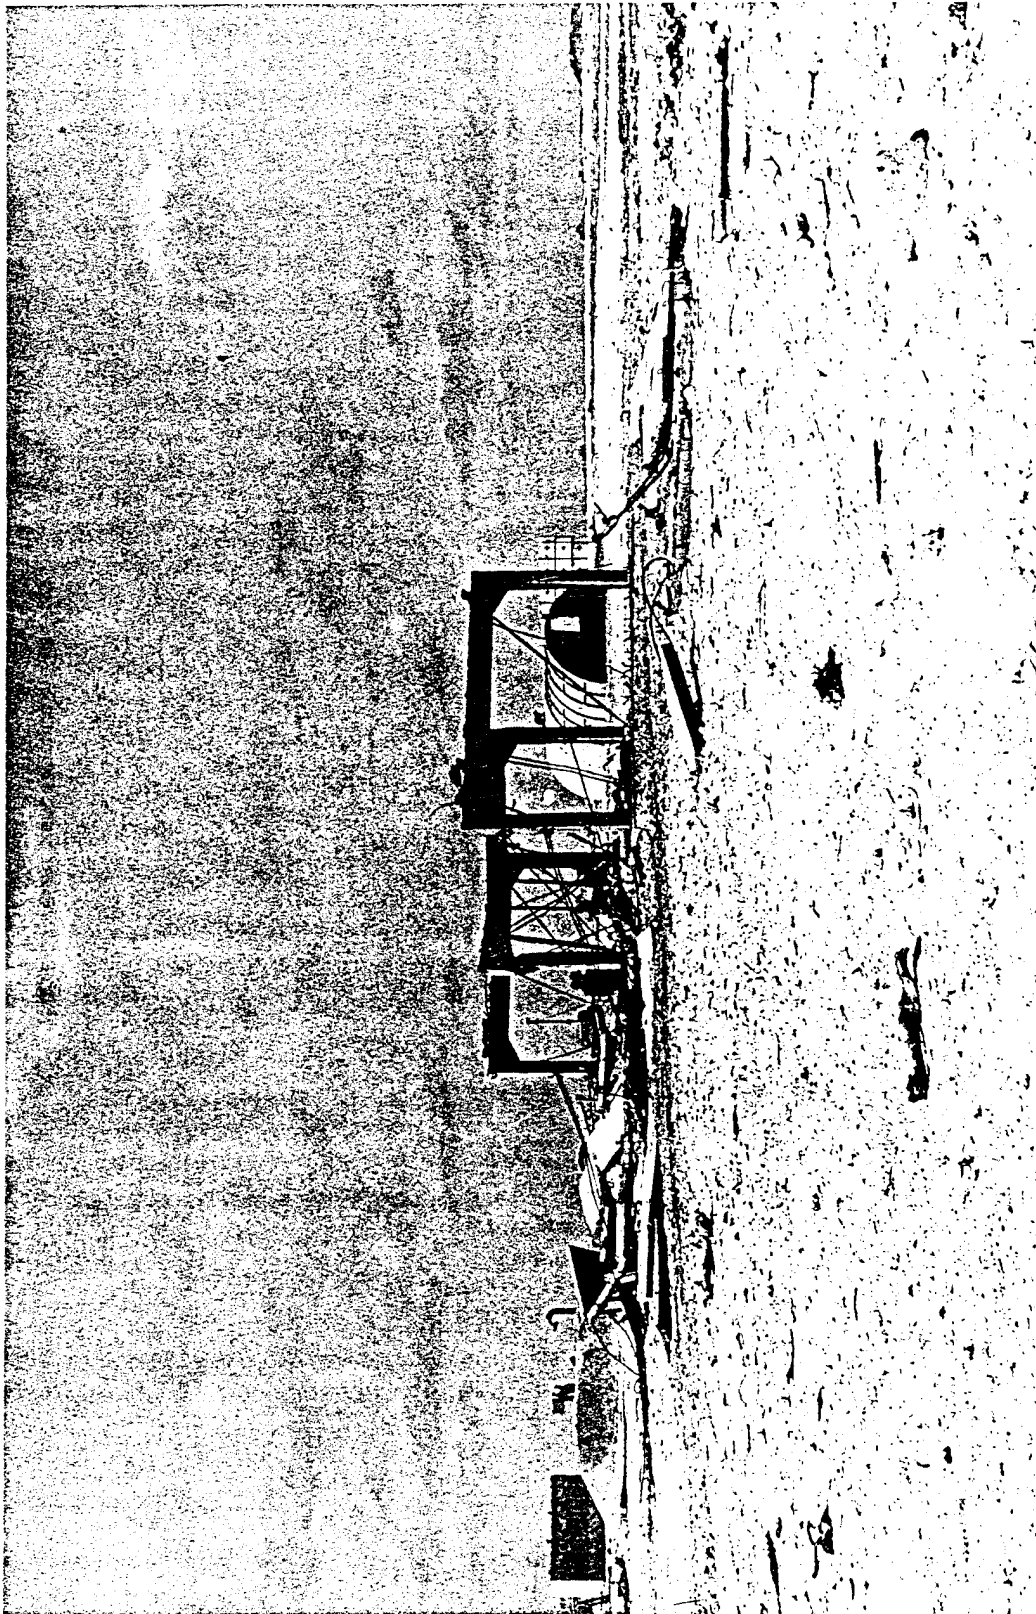
Fig. L.54 View from Left Rear with Left End Wall in Foreground, Structure 3.2.2a

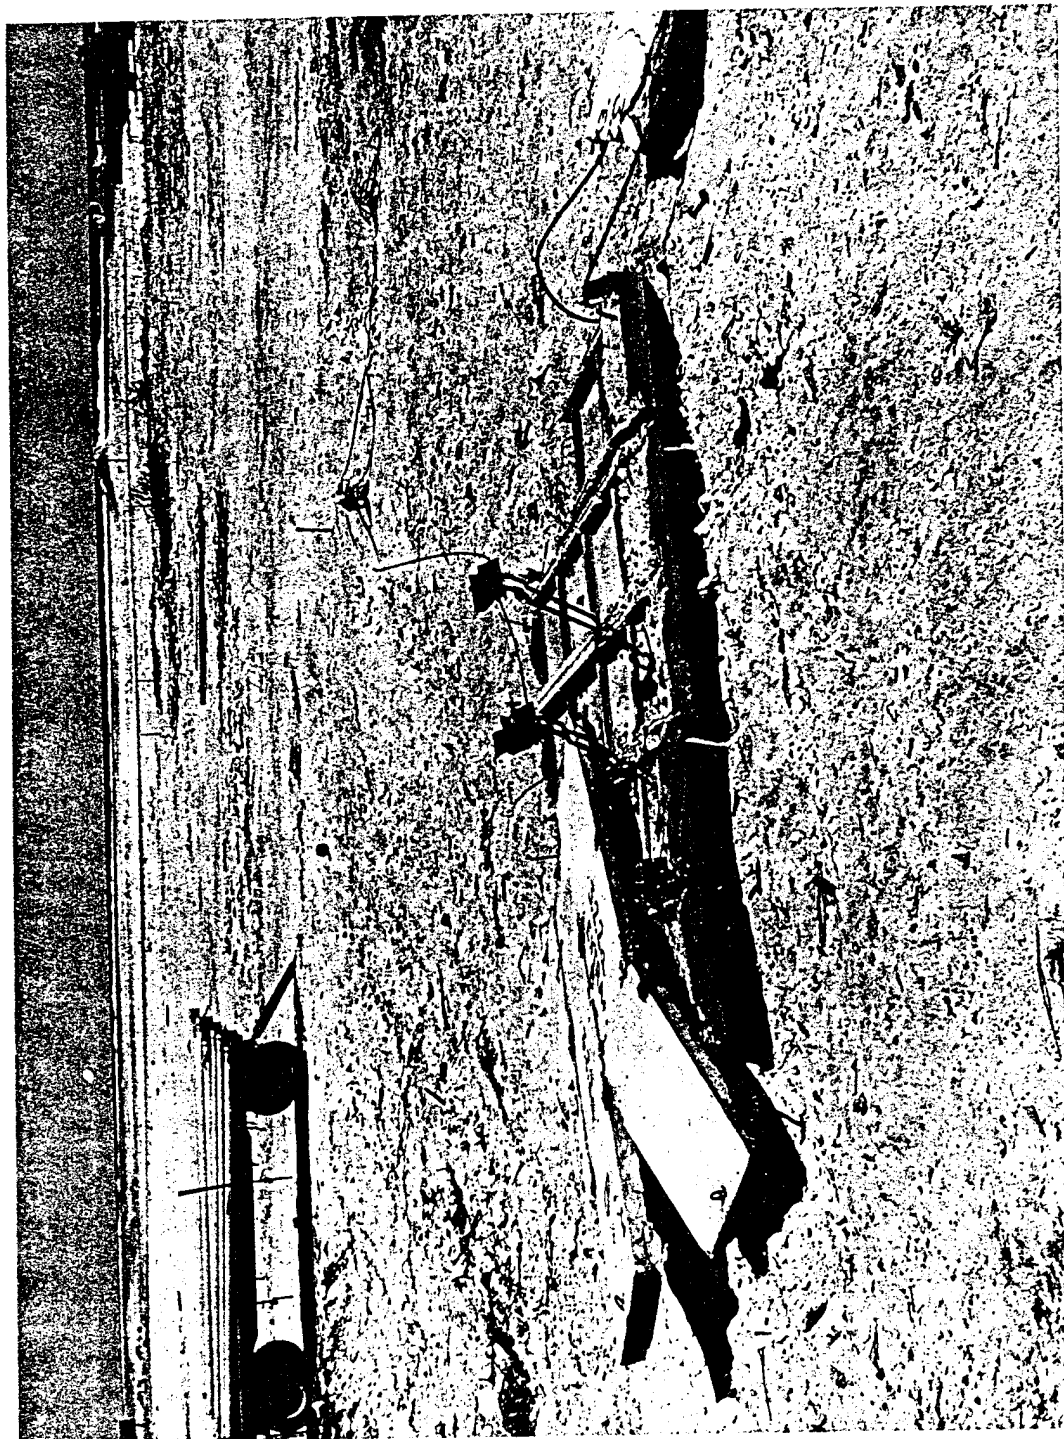
Fig. L.55 Close-up of Left End-wall Panels, Structure 3.2.2a

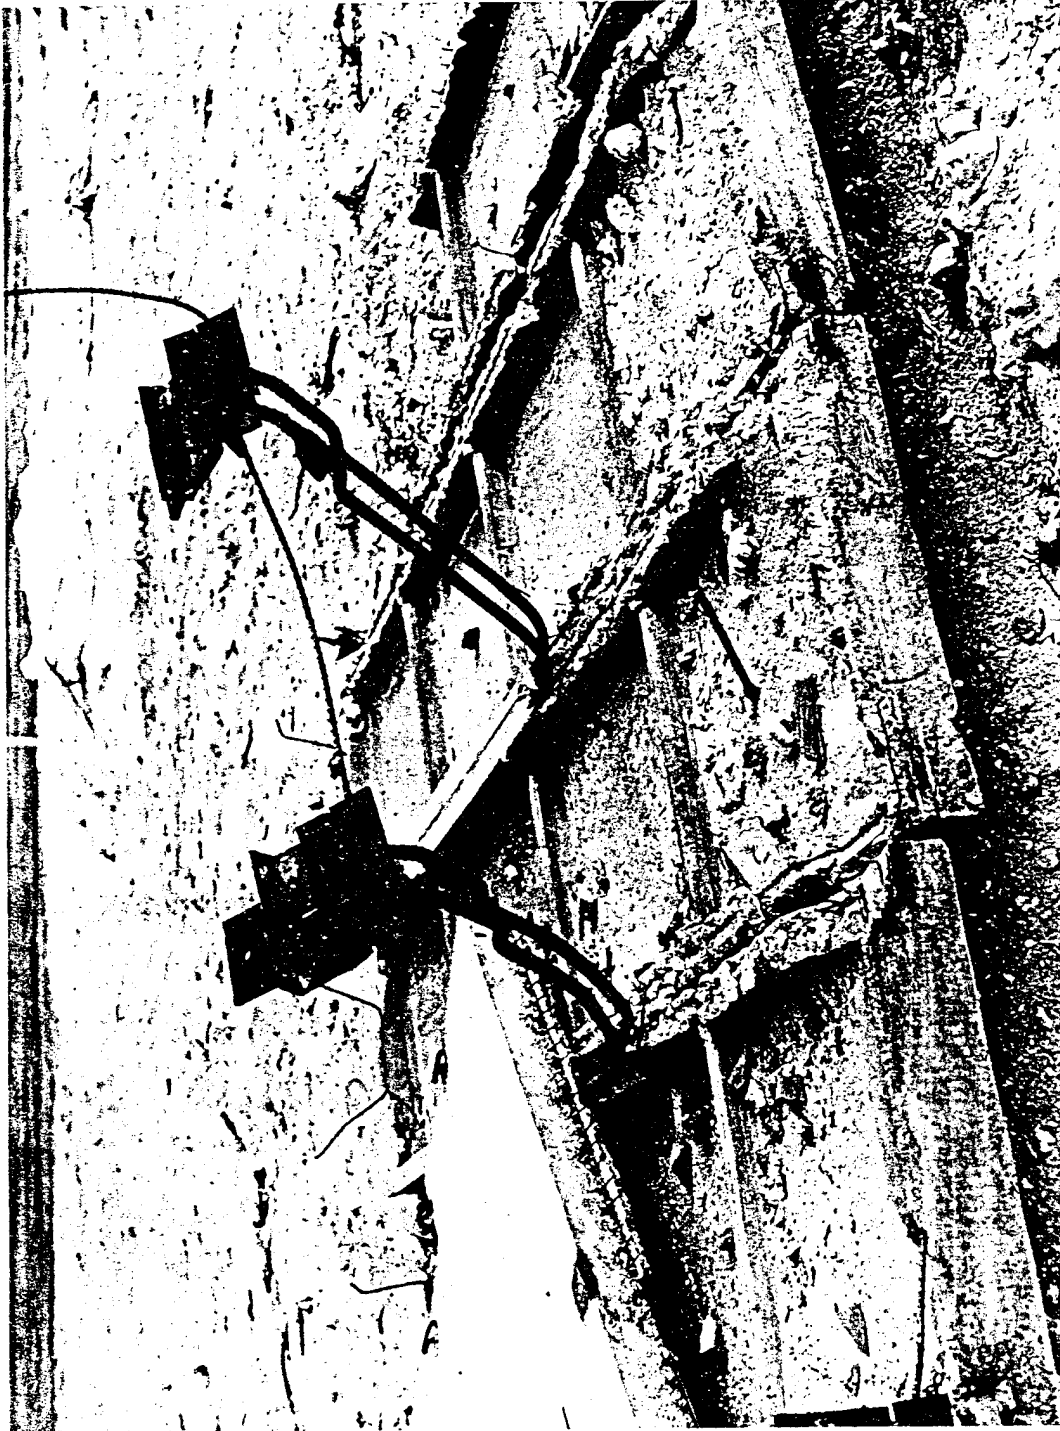
Fig. L.56 Failure of Connection Between Left End Panel and Roof Panel, Structure 3.2.2a. Channel pulled out of roof panel and bent severely.

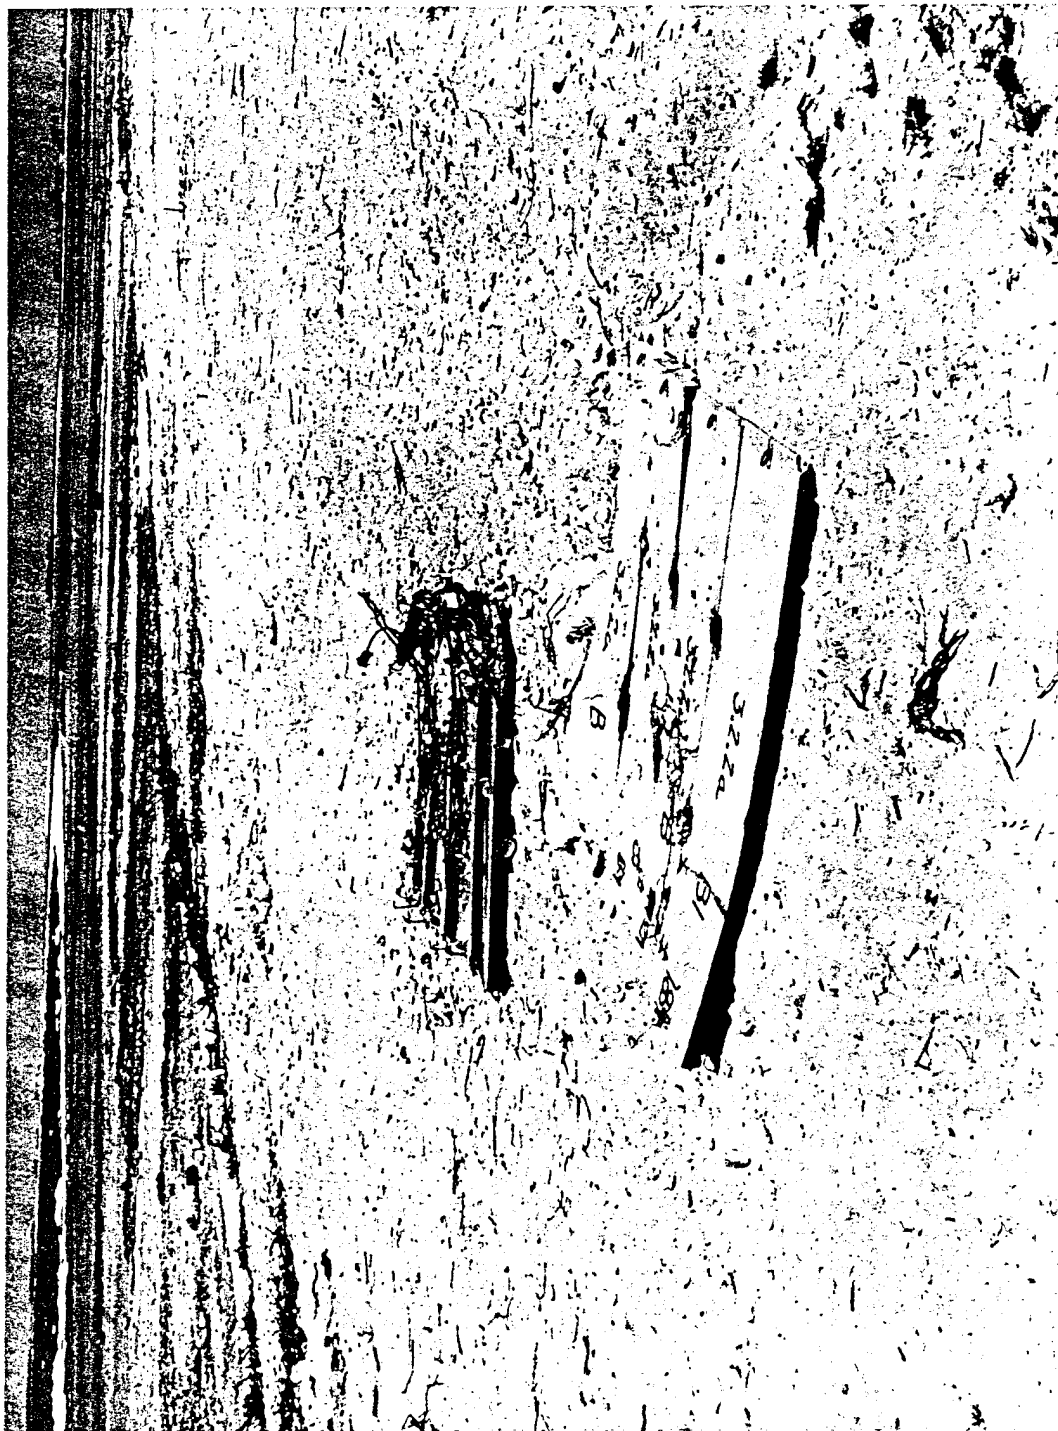
Fig. L.58 Right End Panels Looking from Building, Structure 3.2.2a

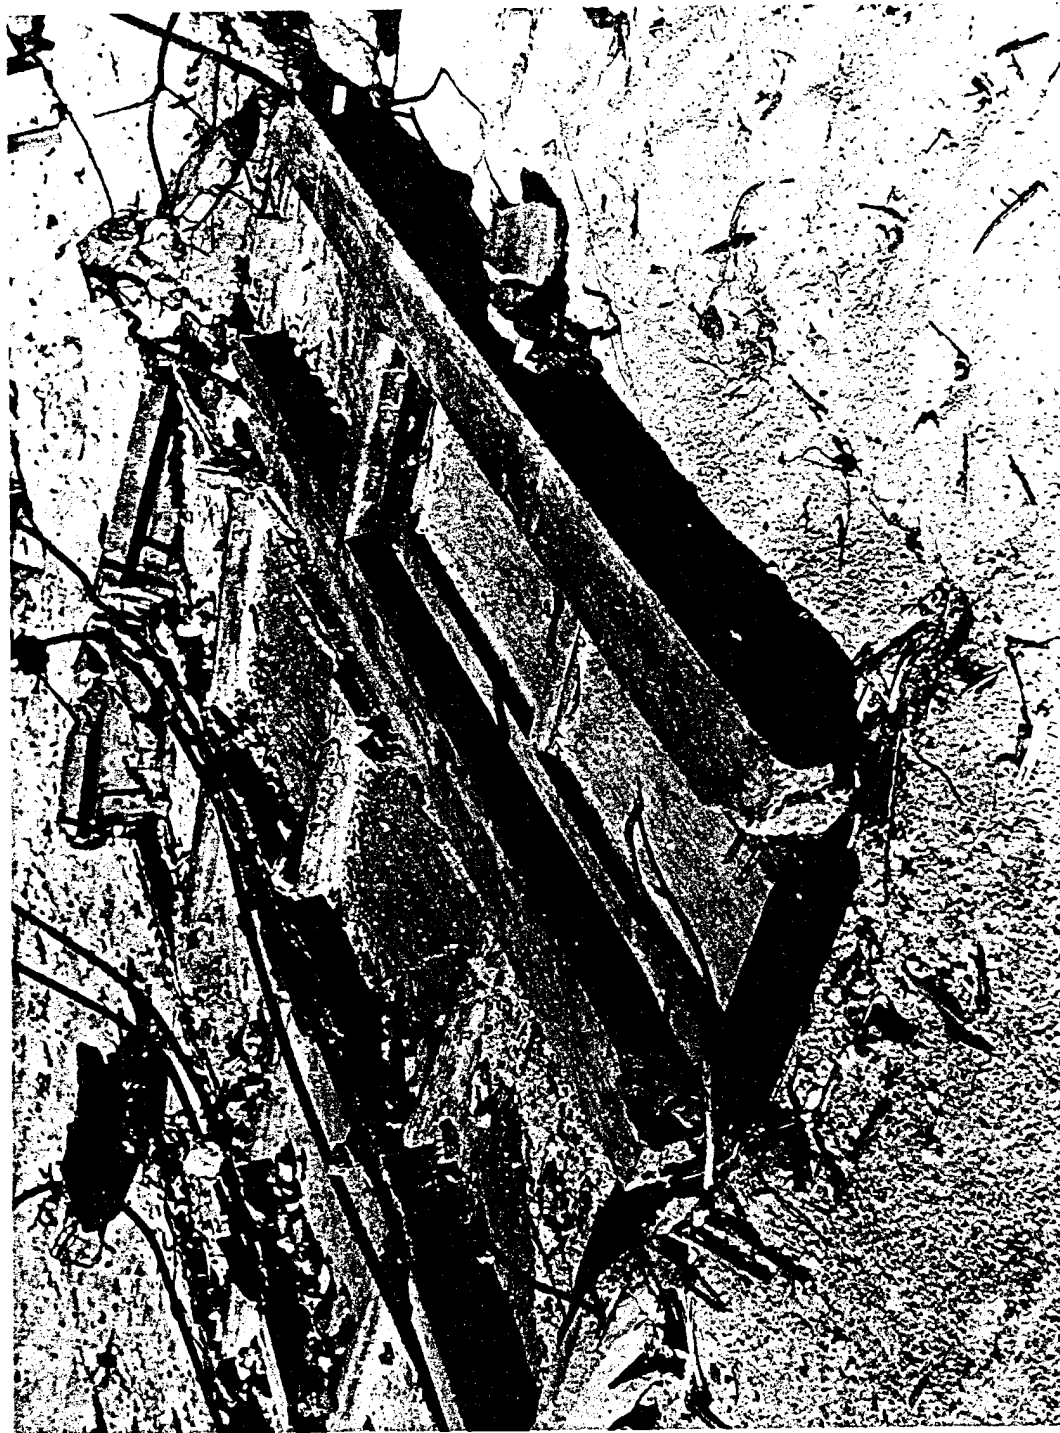
Fig. L.59 Relatively Undamaged Door in Place in End-wall Panel Which Carried 80 ft, Structure 3.2.2a

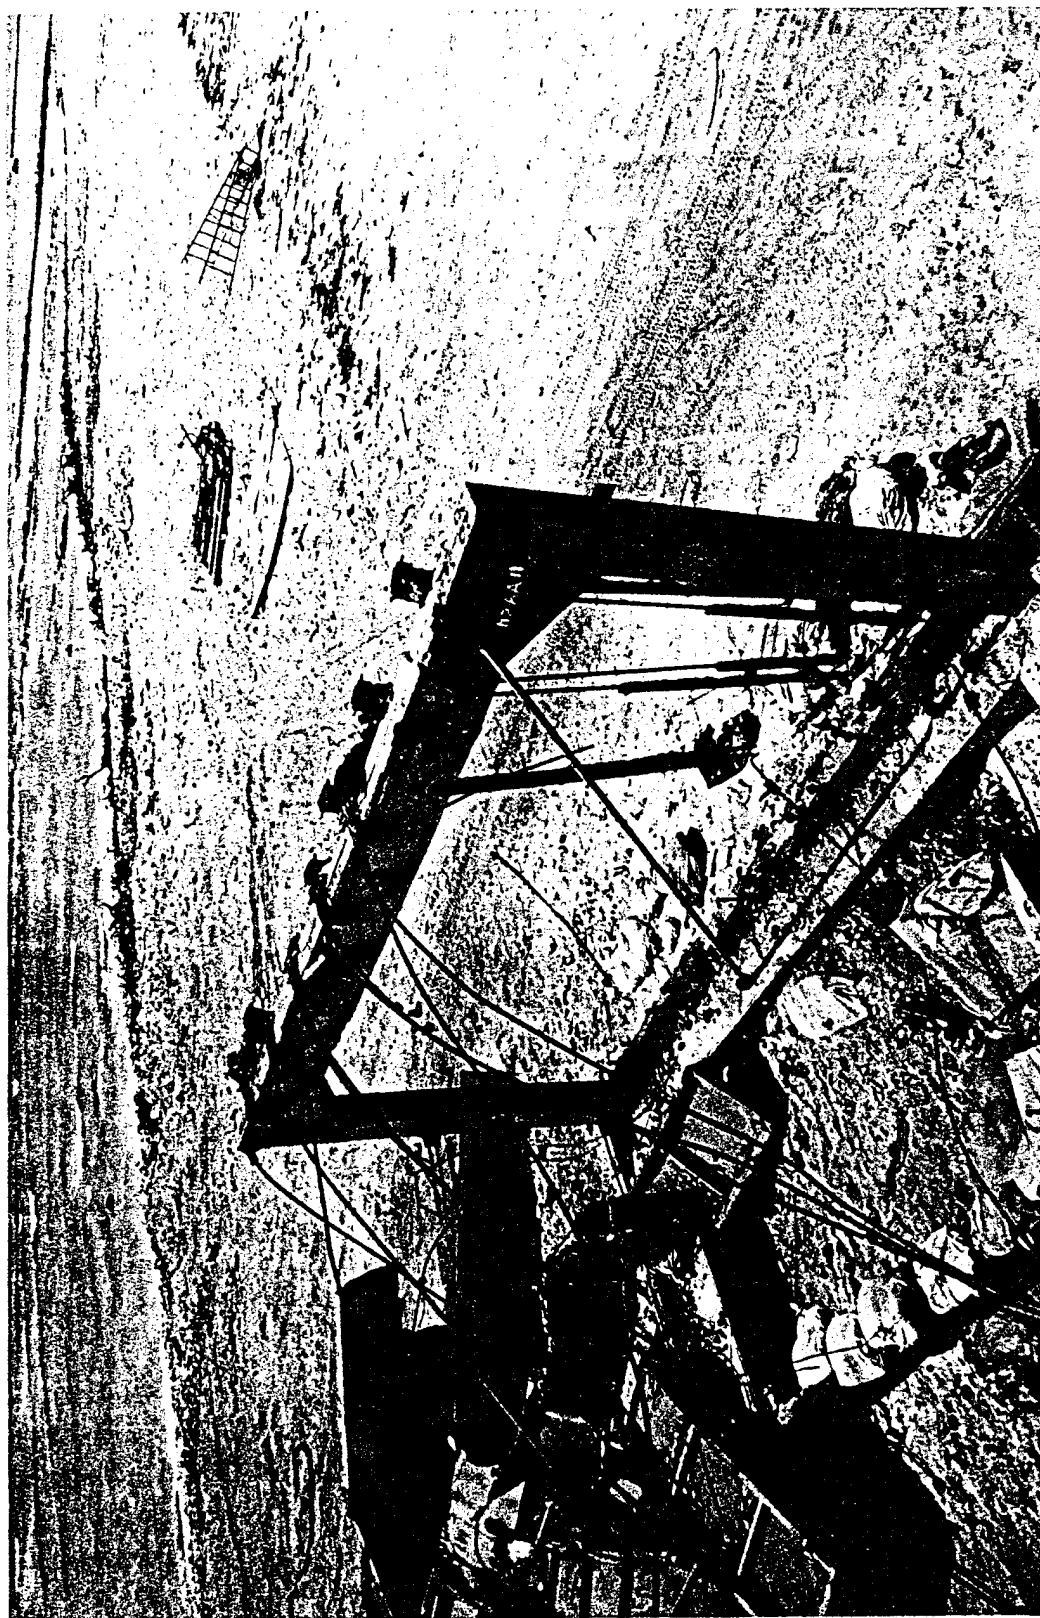
Fig. L.61 View Toward Right End Wall from Front Center, Structure 3.2.2a

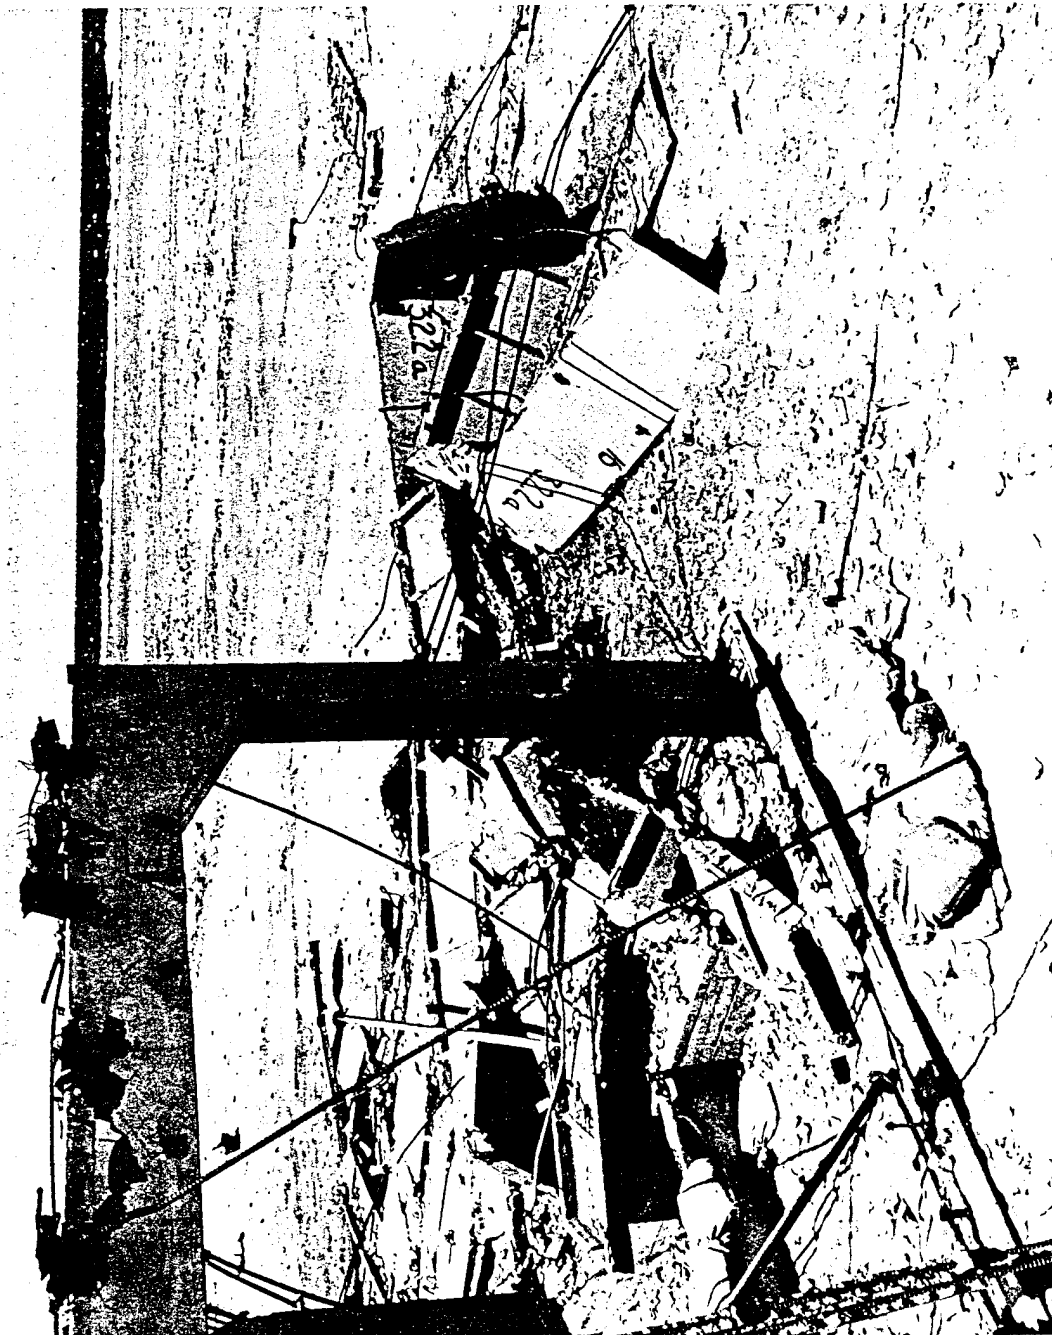
Fig. L.62 View Toward Rear from Right Side, Structure 3.2.2a

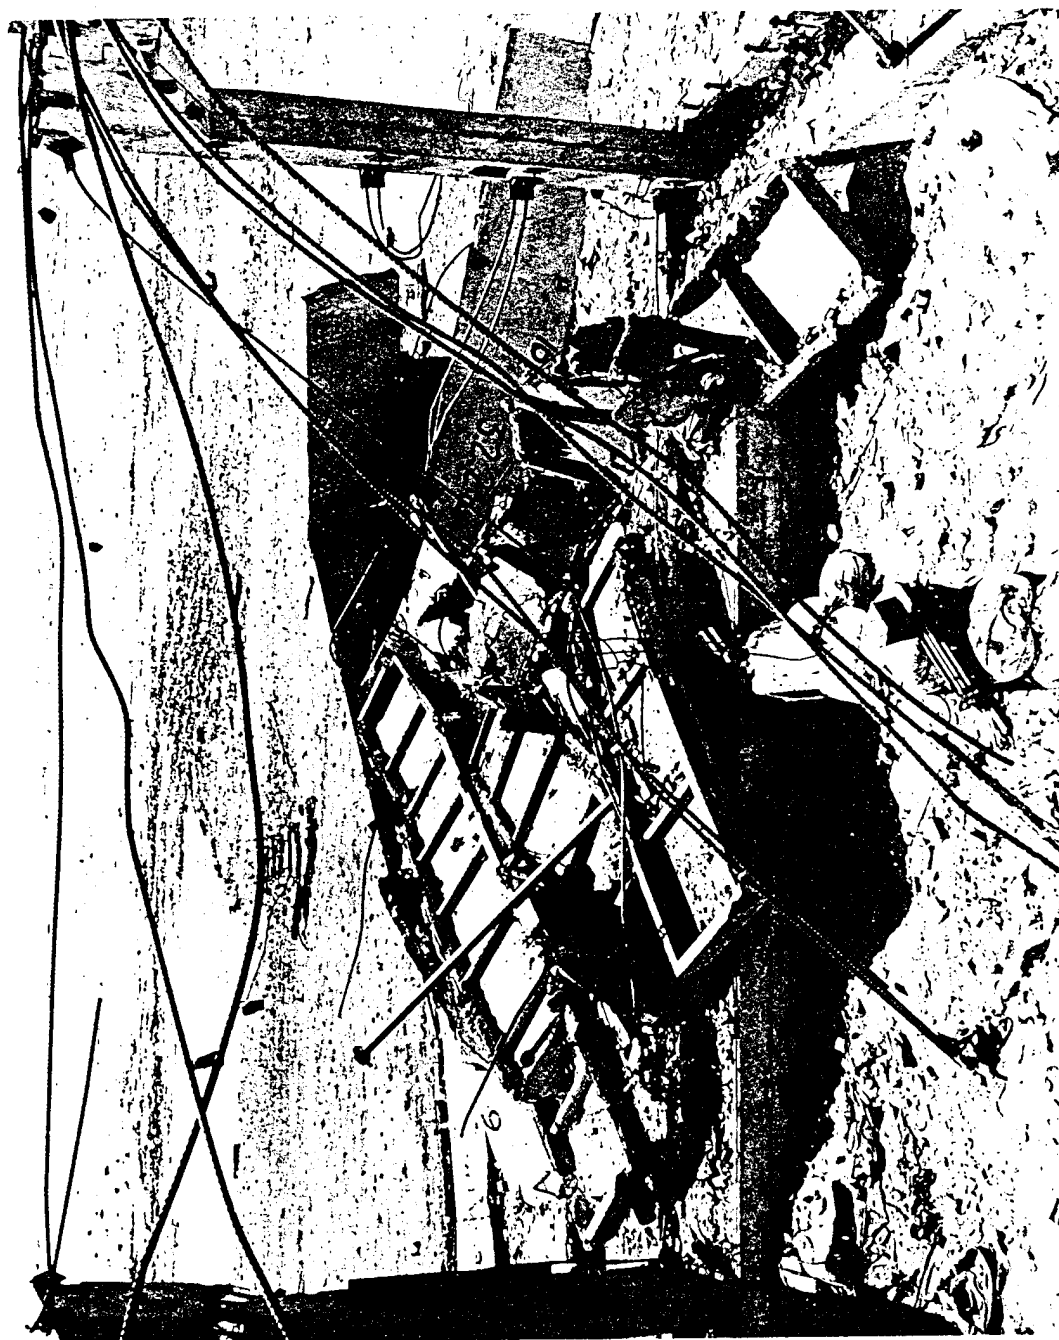
Fig. L.63 Panels behind Right Half of Structure, 3.2.2a. In places, front-wall panels lie beneath rear-wall panels.

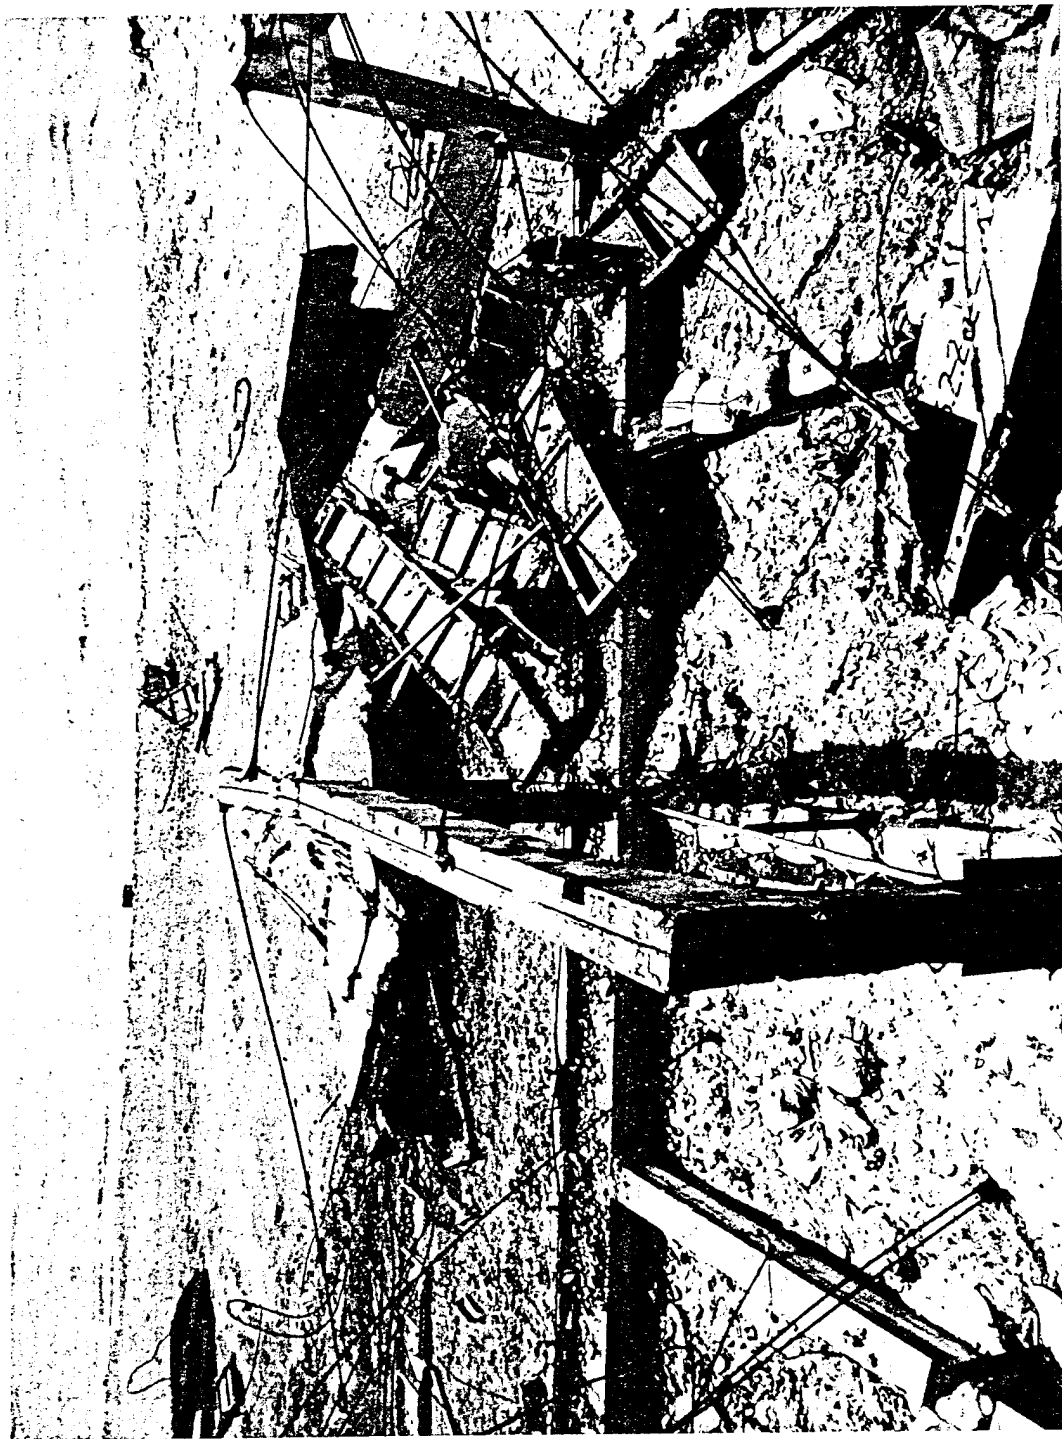
Fig. L.64 Rear of Building from Front Center, Structure 3.2.2a

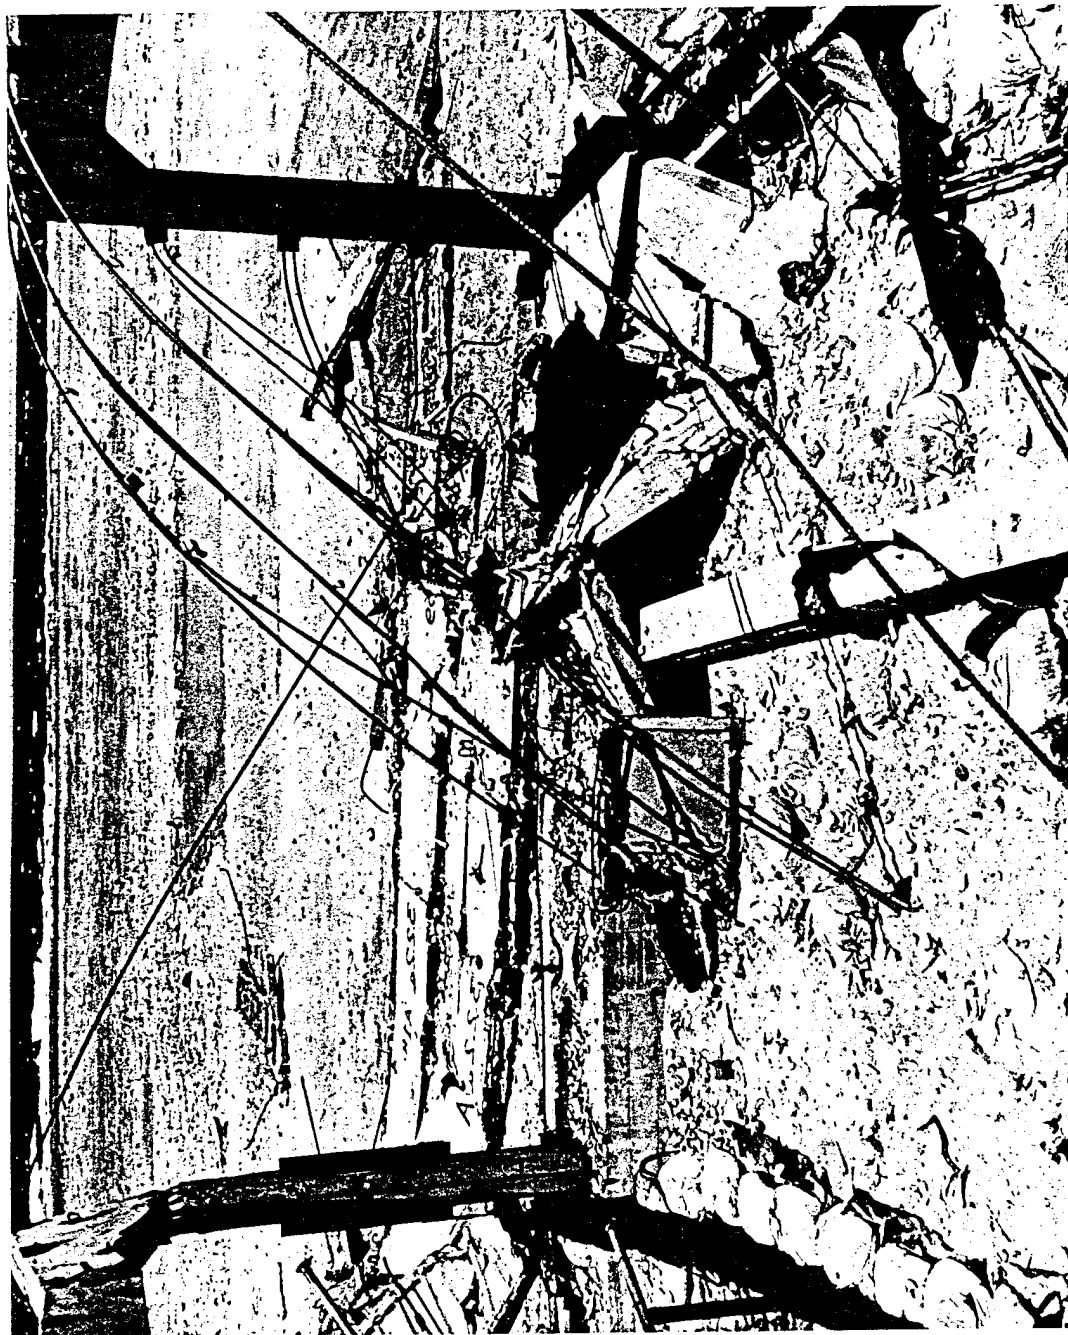
Fig. L.65 Panels behind Left Half of Building, Structure 3.2.2a. A front-wall panel lies farthest to rear except for roof panel in right background.

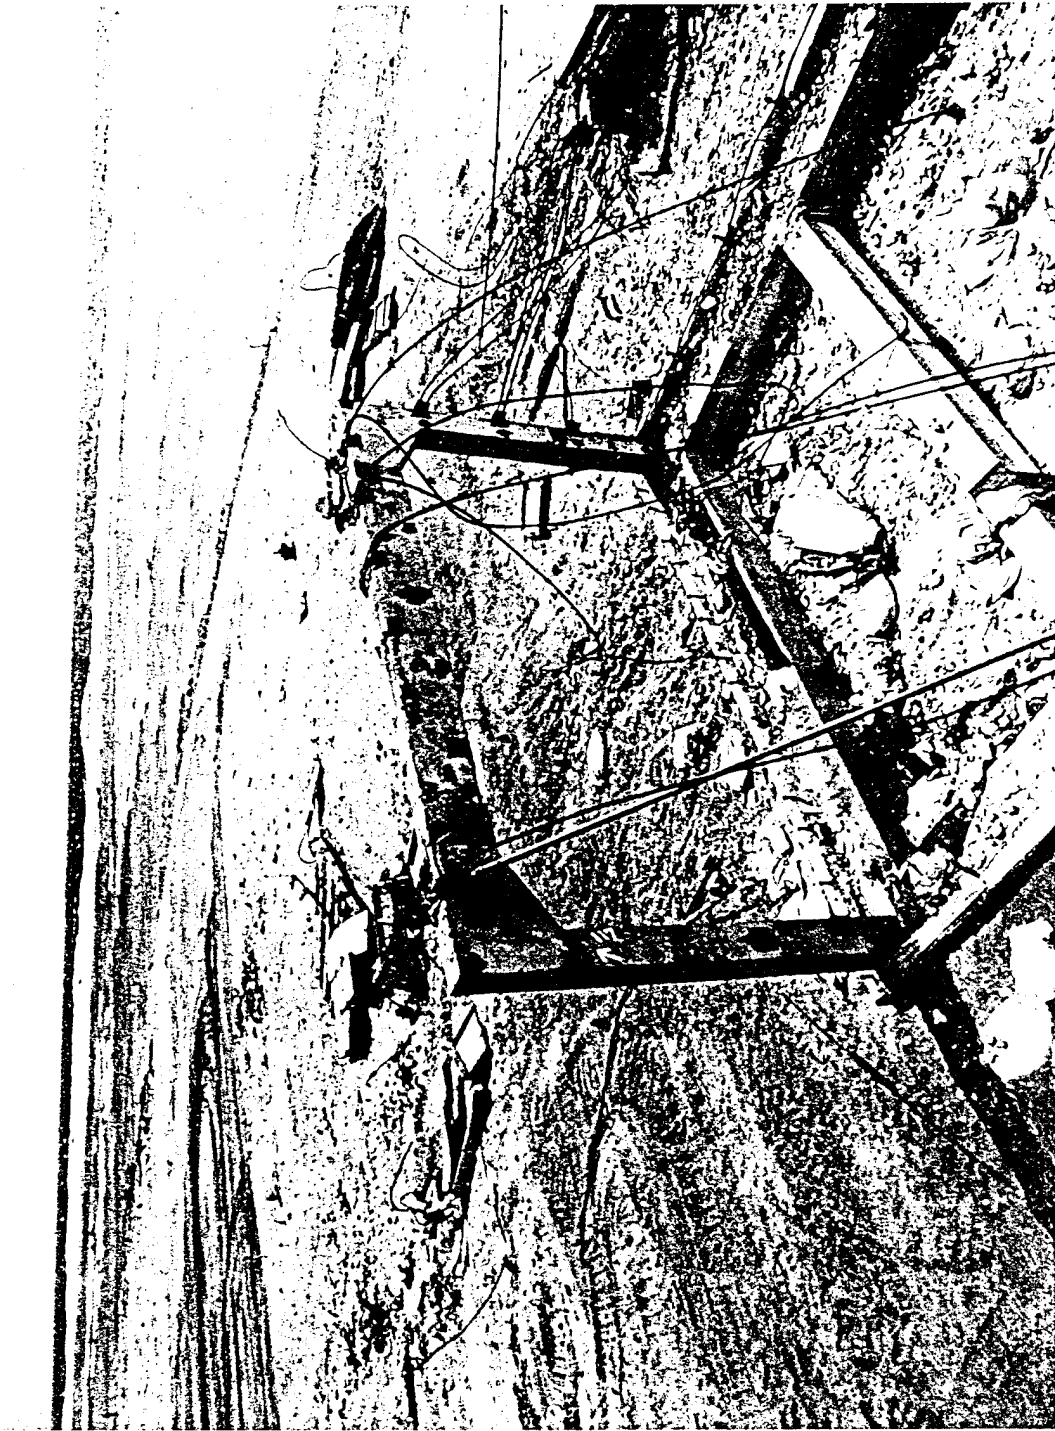
Fig. L.66 View of Left Side from Front Center, Structure 3.2.2a
